Surface Management Site Inspection, Lisbon Valley Mining Company, Lisbon Mine,

UTU-72499 (M/037/0088), San Juan County, Utah.

Date of Inspection: 08/12/2010 Time of Inspection: 9:00 A.M.

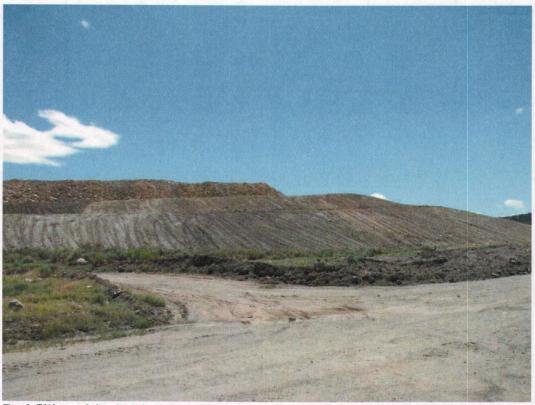
Backfilling of the Sentinel East Pit is complete and expansion of Dump C is progressing to the northwest.

The Sentinel East Pit has been backfilled and the westward expansion of Dump C is progressing. I asked Lantz how they ensured that the waste rock with acid generating potential is properly encapsulated in the backfill. Lantz said that past characterization study of the local rock units has identified the beds with acid generating potential (beds 6-10) and the beds with acid neutralizing potential (beds 1-5 and 11-15). In addition to knowing the acid generating potential of individual

The UDOGM is requiring that check dams be constructed in the drainage around the toe of dump C. According to Lantz, this work has not been completed.

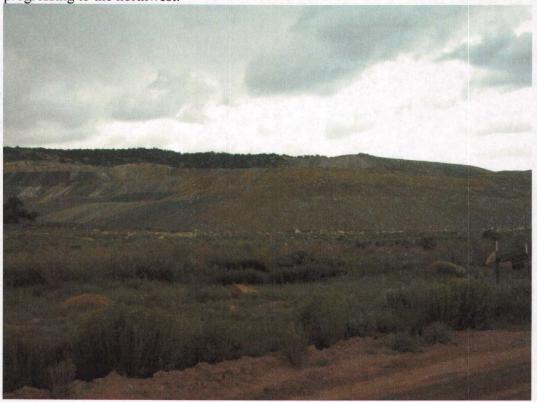
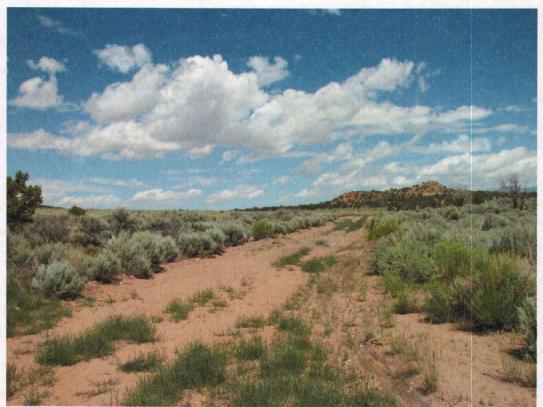
Proposed haul road from GTO Pit to leach pad. Top - Shows approximate route from the GTO Pit to existing water tank. Bottom – Shows approximate route from the water tank to the leach pad. Road construction has not started.

Construction work on the haul road has not started. Lantz said that he needs to submit additional design specifications to the UDOGM before they will give final approval. Lantz and I followed the approximate alignment of the proposed haul road to the GTO Pit using existing roads.

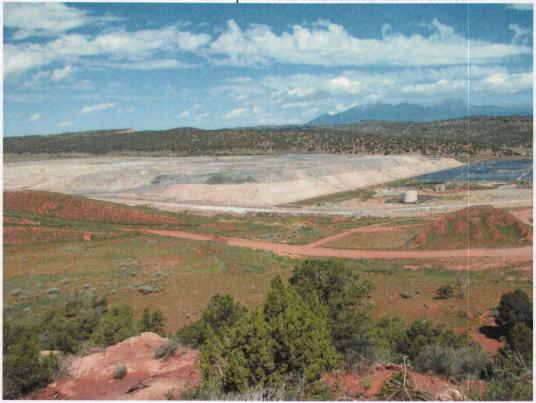
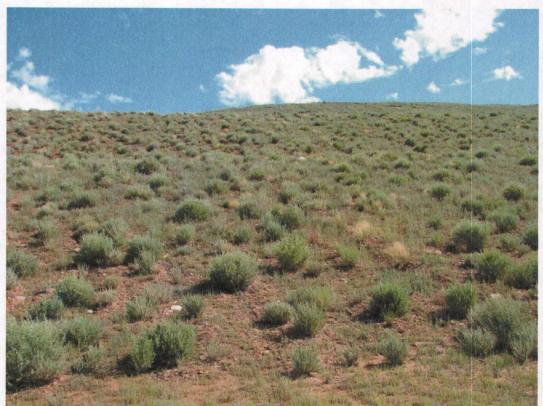
South slope of Dump C. Top – view from toe of slope to the top. Moderate to good cover of Fourwing saltbush with some Indian ricegrass. Note the minor rilling that is occurring and abundance of Russian thistle. Bottom – shows first bench on slope.

Concurrent reclamation work has been done on much of Dump C. There is moderate re-vegetation success in limited areas but the overall success is inadequate. Small rills have developed in the south slope. Rilling is probably due, in part, to past practice of spreading the topsoil and seeding with equipment moving perpendicular to the slope rather than parallel to the slope contour. Fourwing saltbush, Indian ricegrass and some wheatgrass occurs on the slope. These occur in greater abundance at the toe of the slope or on breaks in the slope (benches). Russian thistle is the predominant vegetation type on site. This is even true on top of Dump C where, presumably, vegetation response would be much greater.

- Remedial drill seeding is planned for Dump C this fall. LVM should continue to monitor the site to ensure that rilling does not worsen. Additional remedial work may become necessary to stabilize the site and increase the cover of desirable species. This may require treatment of the Russian thistle at some point.

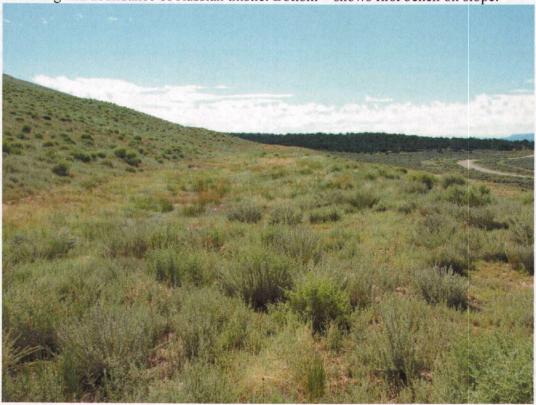
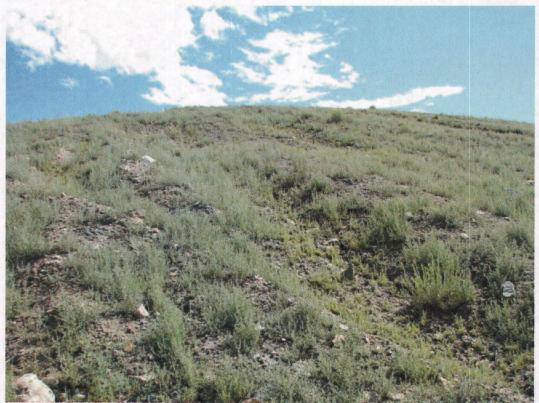
Top – Dump C slope that has not been topsoiled or seeded. Bottom – shows top of Dump C that has been topsoiled and seeded. Again note the predominance of Russian Thistle and lack of desirable vegetation species at both locations.

Topsoil has not been spread on a portion of Dump C. Lantz said that Paul Baker, UDOGM indicated that topsoiling may not be necessary because the waste rock may provide an adequate growth medium. This change in the reclamation plan would require a Plan Modification.

- LVM should do concurrent reclamation each autumn as areas become available. This includes application of topsoil (growth medium) unless a Plan Modification is approved.

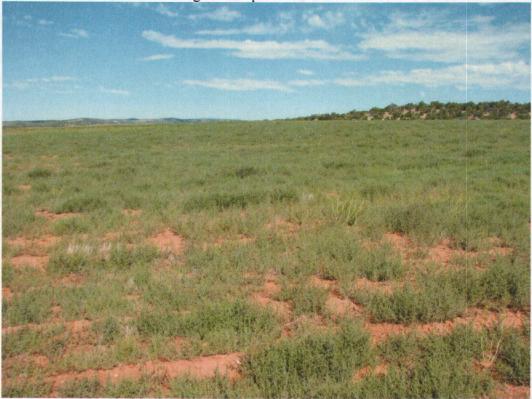
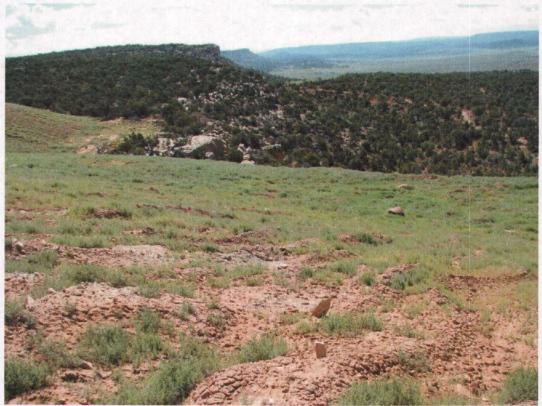
Slope at southeast end of Dump C showing area of possible future expansion. The Slope has been topsoiled but not seeded. Top – view from top looking southeast. Bottom – view from toe of slope looking north-northeast. Again, note rills in slope.

Lantz said that remedial drill seeding is planned this fall. The slope at the southeast end of Dump C has not been seeded because LVM is preparing a Plan Modification to extend the dump to the southeast. The proposed dump expansion would result in the un-seeded slope being covered with additional waste rock from the Centennial Pit.

- LVM still needs to construct check dams in the drainage re-route around the expanded toe of Dump C.
- LVM should seed the southeast end of Dump C if a Plan Modification to expand the dump is not received and approved before next fall.

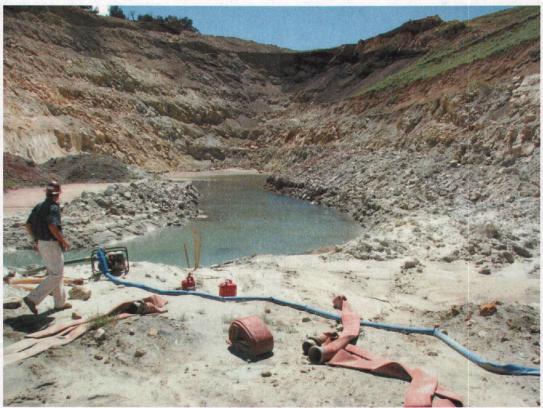
Top – Shows bottom of Sentinel West Pit. Small pool of water has formed from ground water in the Burro Canyon Aquifer. Bottom – Construction of Phase 3 Heap. A 3-ft protective cover consisting of minus 3/4 inch ore is being placed over the liner.

Operations are complete at the Sentinel West Pit. In its ROD, the BLM decided not to backfill the Sentinel West Pit because the pit bottom is below the water table and alkaline leachates could develop which may degrade the deeper Entrada/Navajo aquifer. We visited the site to observe the pool of water in the bottom of the pit formed by ground water in the Burro Canyon aquifer.

Construction of the Phase 3 heap has begun. A 3-ft protective cover consisting of minus ³/₄ inch ore is being placed over the liner (80 Mil HDPE). Heap construction is monitored and inspected by the State of Utah to ensure compliance with the terms of its Ground Water Quality Discharge Permit.
